MAINTAINING POWERLINES

High-resolution imagery enables desktop inspection of assets

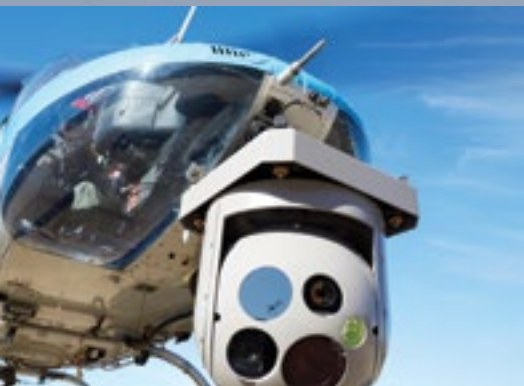
AAM's multi-sensor acquisition systems deliver integrated, georeferenced datasets and the next step change to utilities' network asset and vegetation mapping.

The Quad 400 combines high resolution video and still images, with Infrared (IR) and Ultraviolet (UV) sensors into one acquisition system. As all of the sensors are mounted in the gimbal, which allows the operator to direct the sensors to specific assets or faults, the sensors remain synchronized and geo-referenced with GPS positioning.
