## CASE STUDY

### Qualifying accuracy & integrity of complex steel structure

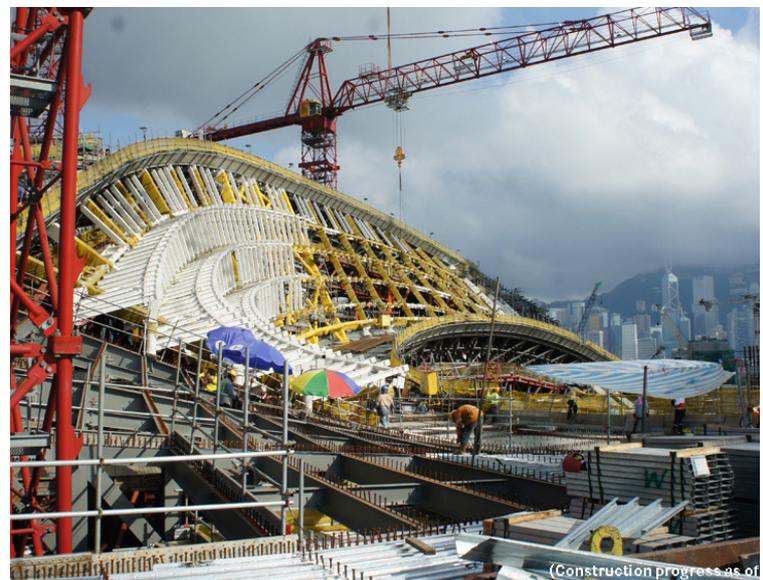
The iconic roof of the West Kowloon Terminus and its complex steel structure. Image captured onsite, during the installation and erection of the steel structure in June 2017.
